CHAPTER IV:  
CONCEPTUAL TREATMENT

### *Treatment Philosophy*

## ***Landscape Character Areas***

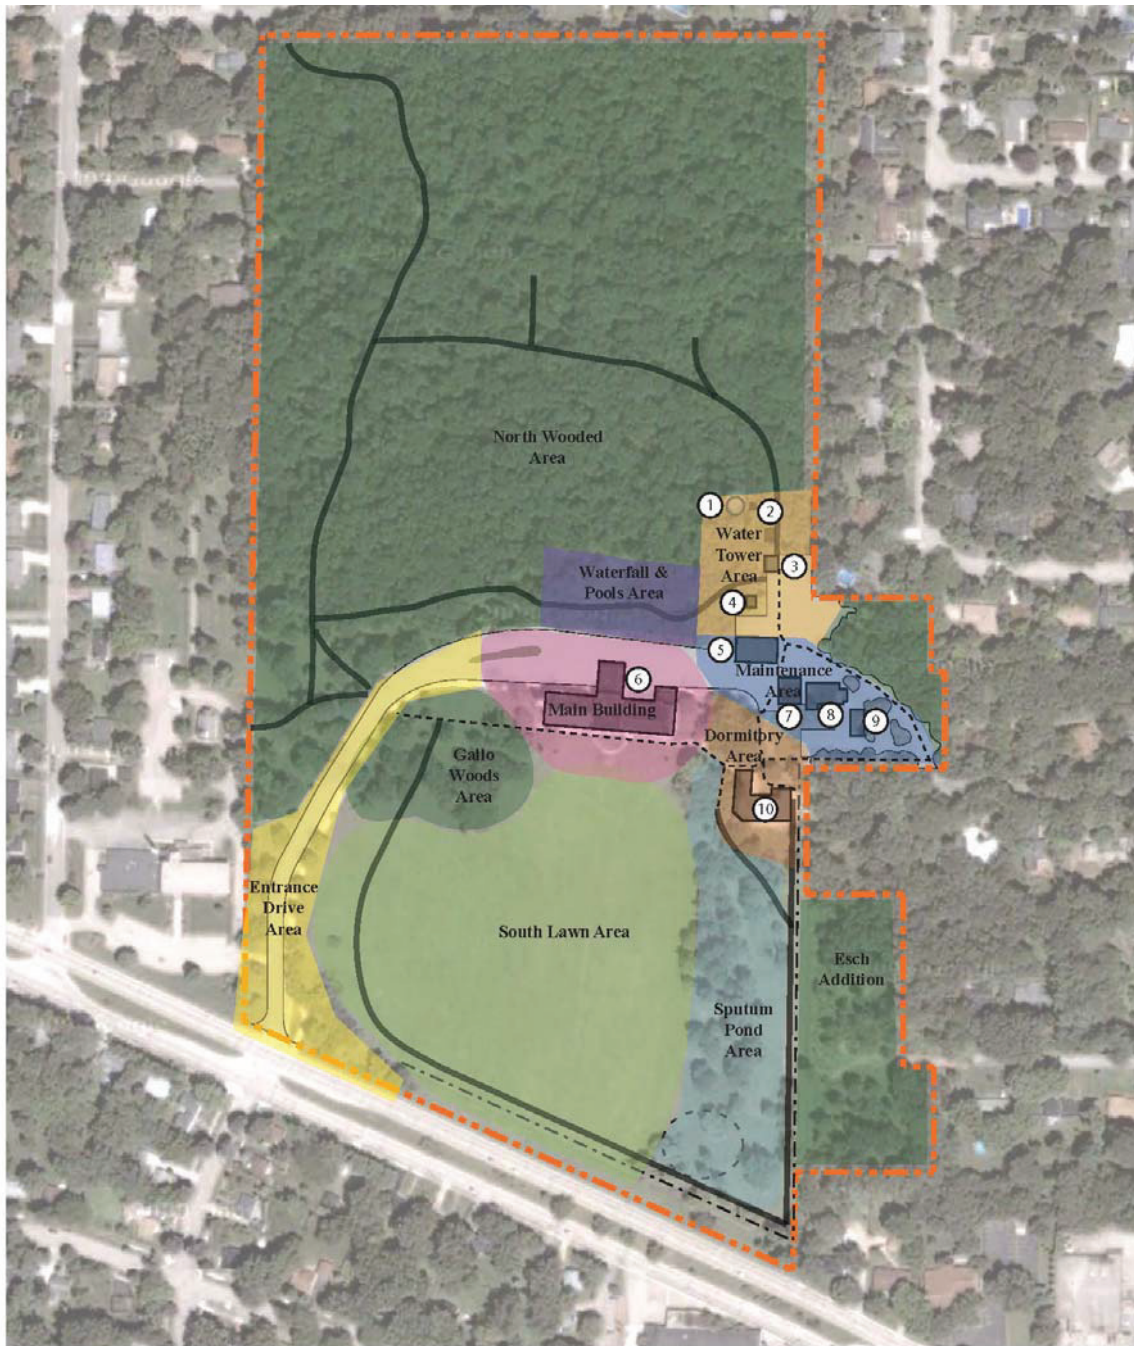
Figure 4- 1: Lake View Hill Park, Landscape Character Areas (source: QEA)

The landscape of Lake View Hill Park is described herein as a unified property made up of ten landscape character areas. Landscape character areas are defined by their combined physical qualities and cultural resources. The Lake View Hill landscape character areas are illustrated in Figure 4-1. They include:

1. **South Lawn Area:** the hill that slopes down from the Sanatorium to Northport Drive has contained a mown lawn since the establishment of the institution in 1930.

2. **Sputum Pond Area:** this area, located on the eastern portion of the property south of the dormitory, contains remnants of ornamental landscape features that were present during the operation of the Sanatorium. Included are remnants of sputum pond, portions of two ornamental cement lined streams, a cement path, and ornamental plants.

3. **Dormitory Area:** the dormitory, related circulation routes, remnants of historic features, vegetation, and stone retaining wall are all included in this character area.

4. **Main Building Area:** the main building (Sanatorium, Administration building), related circulation routes, adjacent parking, vegetation, ornamental archway, and fountain/planter are all included in this area.

5. **Gallo Woods Area:** this area includes the mature oak woods located to the southwest of the main building.
6. **Entrance Drive Area:** the steep main entrance drive to the property, entrance signs, sidewalk, ornamental plants, and street trees are included in this character area.

7. **Water Tower Area:** located northeast of the main building and north of the maintenance area, the water tower area includes the water tower, several small utility buildings, surrounding vegetation, and a large paved area used for parking.

8. **Maintenance Area:** located to the east of the main building, this area includes three historic service buildings and one non-historic utility building, surrounded by an asphalt driveway on the north and a deteriorated driveway on the south.

9. **Waterfall & Pools Area:** located to the north of the parking lot and main building, this area contains remnants of large pools and ornamental stone waterfall that was present during the historic period.

10. **North Wooded Area & Esch Addition:** these areas contain native woodland communities that are currently the focus of ecological restoration activities. They also include remnants of historic activities that occurred during the operation of the Sanatorium.
